**Maline Creek  
Whole Body Contact Recreation  
Use Attainability Analysis**

**July 2005**

**Prepared for:**  
**METROPOLITAN ST. LOUIS SEWER DISTRICT**  
2350 Market Street  
St. Louis, Missouri 63103

**Prepared by:**  
**MEC WATER RESOURCES, INC.**  
1000 North College Avenue, Suite 4  
Columbia, Missouri 65201

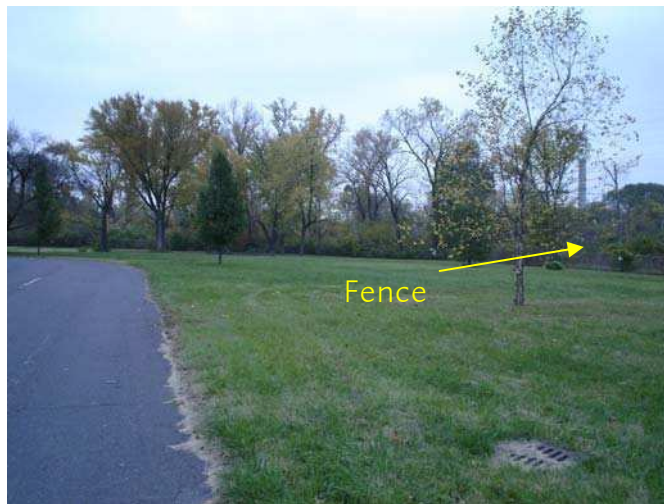
Figure 3. Doherty City Park

Six sites along classified reaches of Maline Creek were assessed for existing, potential, and attainable recreational uses. All sites are located within the urban boundaries of Bellefontaine Neighbors, MO and St. Louis, MO. Doherty City Park adjacent to Sites 1 through 4, is bordered by a tall chain link fence that impedes access to Maline Creek (Figure 3).

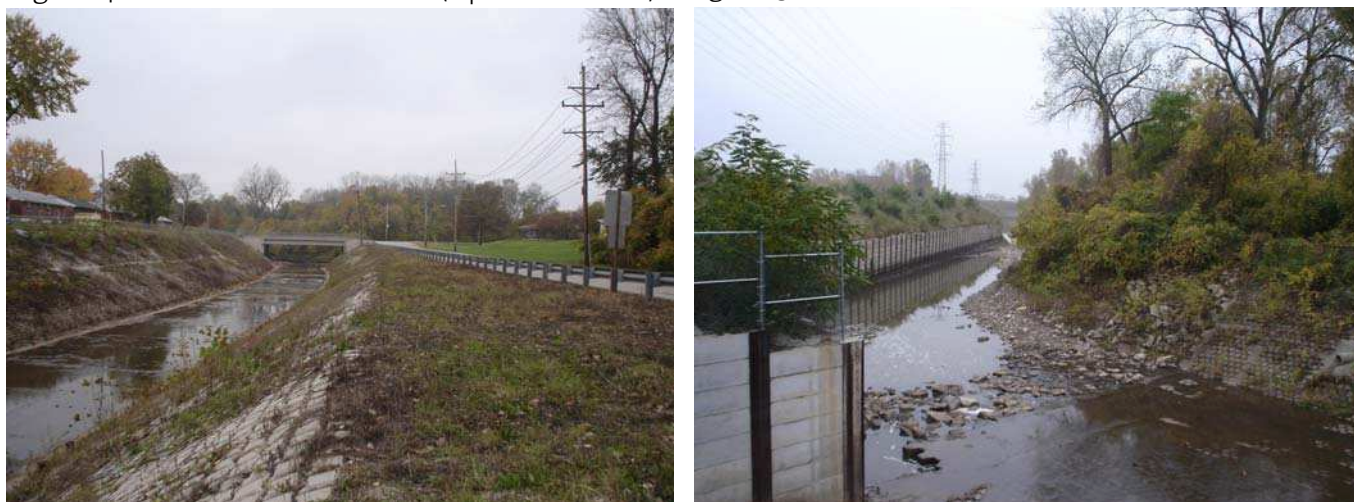
Figure 4. Maline Creek at Site #1 (Upstream View)    Figure 5. Maline Creek at Site #1 (Downstream View)

Streamflow is transported as a thin sheet across a concrete channel at Site #1. Mean depth along a representative transect was 0.06 ft while the maximum observed depth was 0.1 ft. Waters were observed to be odorless, clear, and free of deposits. The presence of roads were the only signs of potential human use at this site (Table 1).

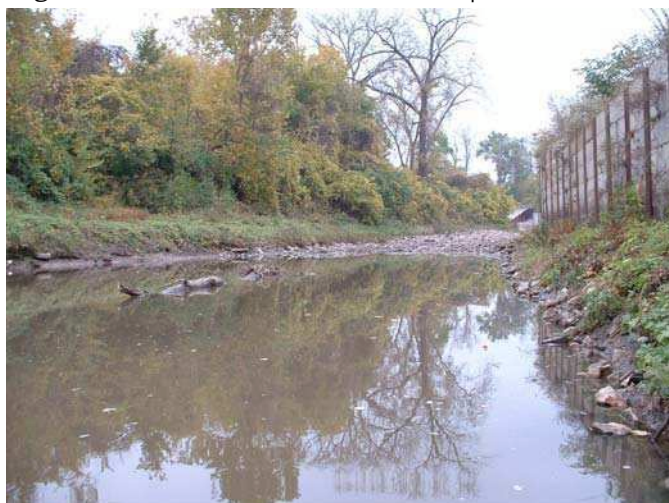
Figure 6. Maline Creek at Site #2 (Upstream View)

A fence adjacent to a dense riparian corridor and constructed vertical wall along the channel may impede recreational use at Site #2 (Figures 6 and 7). Banks are steep and composed of a mud/cobble mixture on the left descending bank and a vertical constructed wall on the right descending bank.

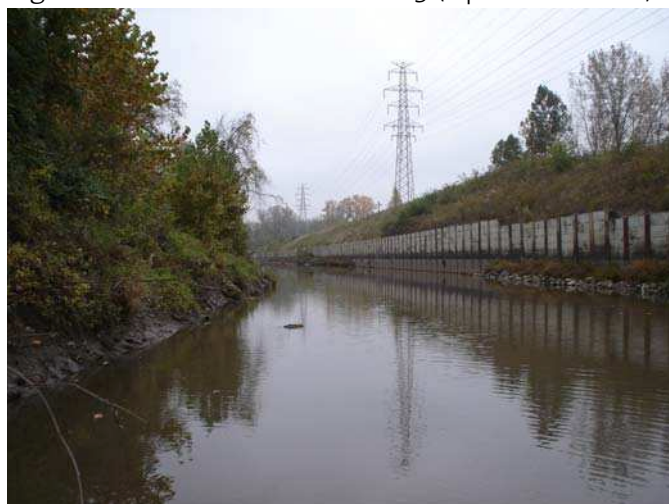
Figure 8. Maline Creek at Site #3 (Upstream View)

A fence adjacent to a dense riparian corridor and constructed vertical wall along the channel may impede recreational use at Site #3 (Figures 8 and 9). Banks are steep and composed of a mud/cobble mixture on the left descending bank and a vertical constructed wall on the right descending bank.

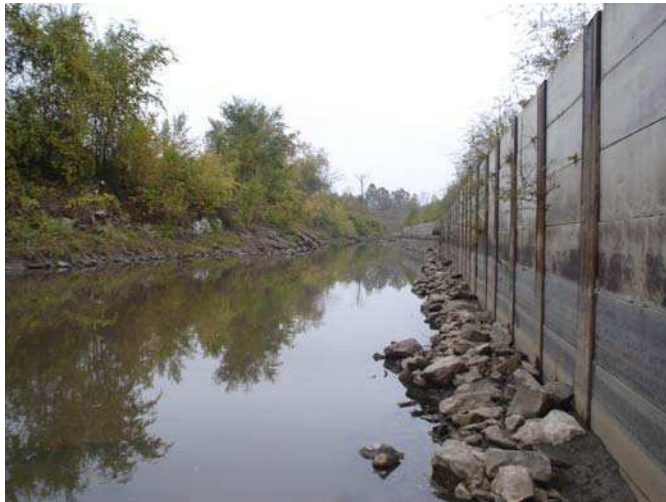
Figure 10. Maline Creek at Site #4 (Upstream View)

Although stream access is limited, graffiti along a small section of concrete streambank (Figures 10 and 11) suggests that fences and vertical containment walls at the site may not prevent determined access to the site.

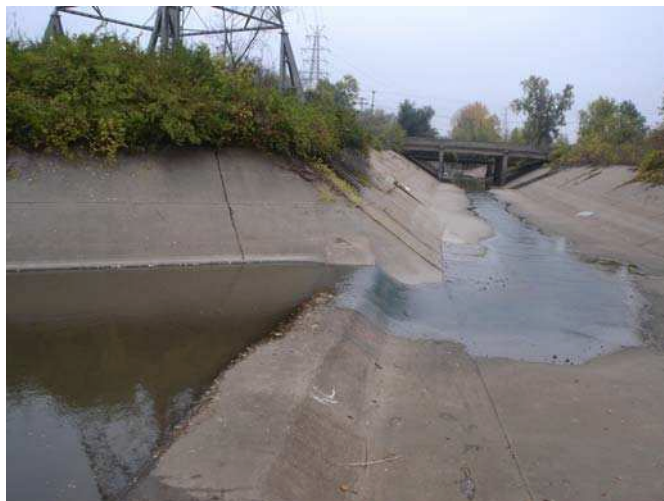
Figure 12. Maline Creek Control Structure near Site #4

Streamflow is slowed by a control structure (Figure 12) just downstream of Site #4, which likely represents the deepest section of Maline Creek. Mean depth across a representative transect was 2.1 ft. while the maximum observed depth was 4.3 ft. Channel substrate is mostly cobble upstream of the control structure and concrete-lined below.

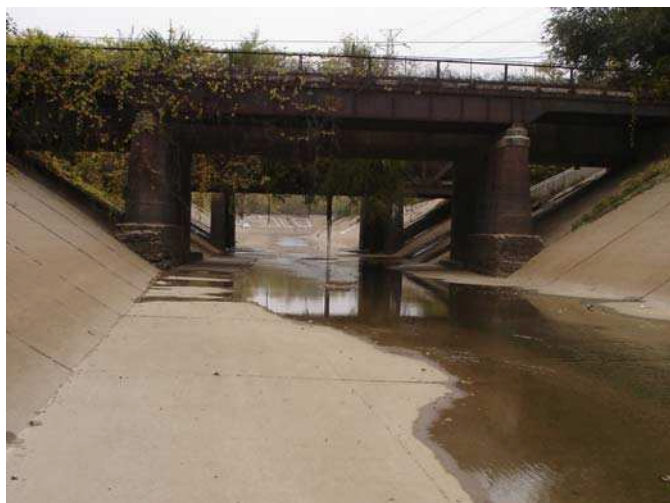
Figure 13. Maline Creek at Site#5. (Upstream View)

Upstream of Site #5, the Maline Creek stream channel features steep concrete embankments and a sparse riparian corridor (Figure 13). Downstream, the stream transitions to a less disturbed state having natural substrates and more defined riparian areas (Figure 14).

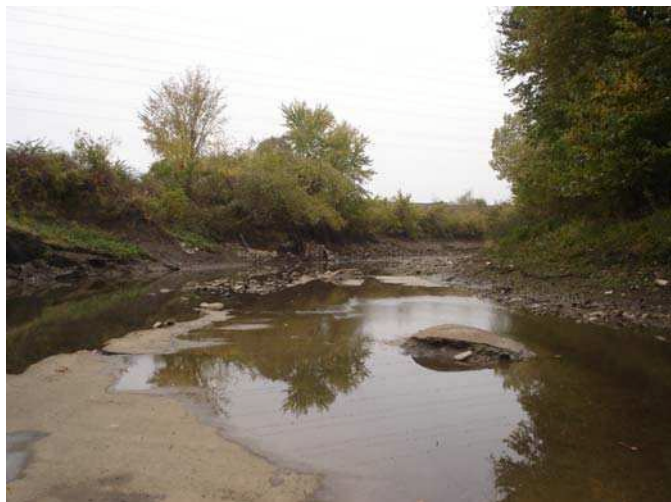
Figure 15. Maline Creek at Site#6. (Upstream View)

Site #6 features steep cobble-strewn banks with a fence along the floodplain and a concrete lined channel (Figures 15 and 16). The riparian corridor is a thick mix of forbs and young trees. Manmade alterations to the stream channel terminate at a vertical drop approximately 300 feet upstream from the Mississippi River (Figure 17).

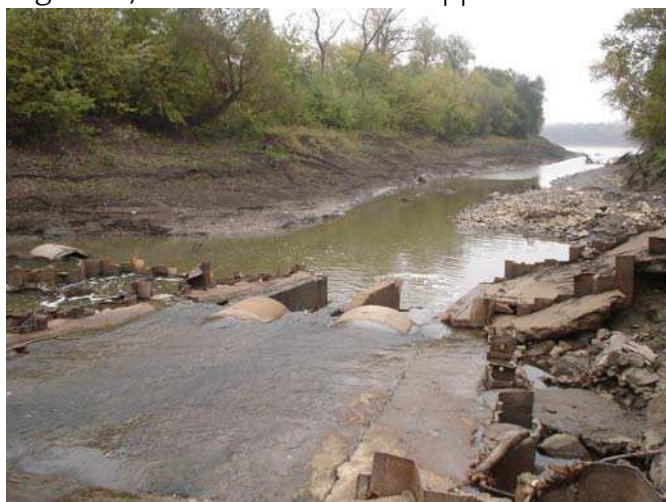
Figure 17. View of the Mississippi River Confluence

Streamflow is contained within a concrete channel as sheet flow. Mean depth measured 0.2 ft while the maximum observed depth was 0.8 ft. Waters were observed to be odorless, clear, free of deposits, and having limited growths of benthic algae (Table 6). Signs of potential human use were limited to graffiti near a bridge crossing. A CSO outfall is present within this reach.

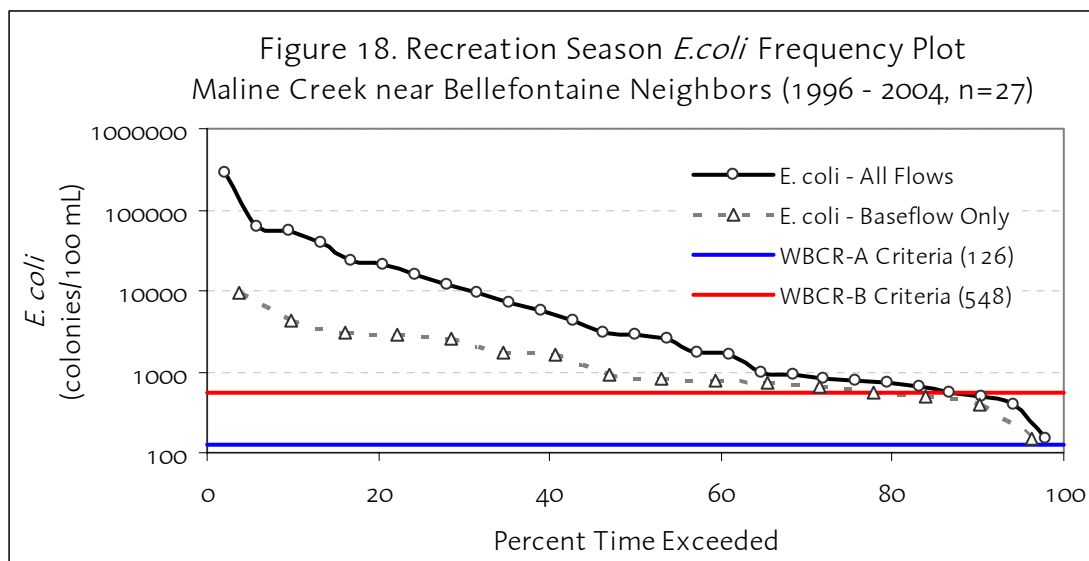
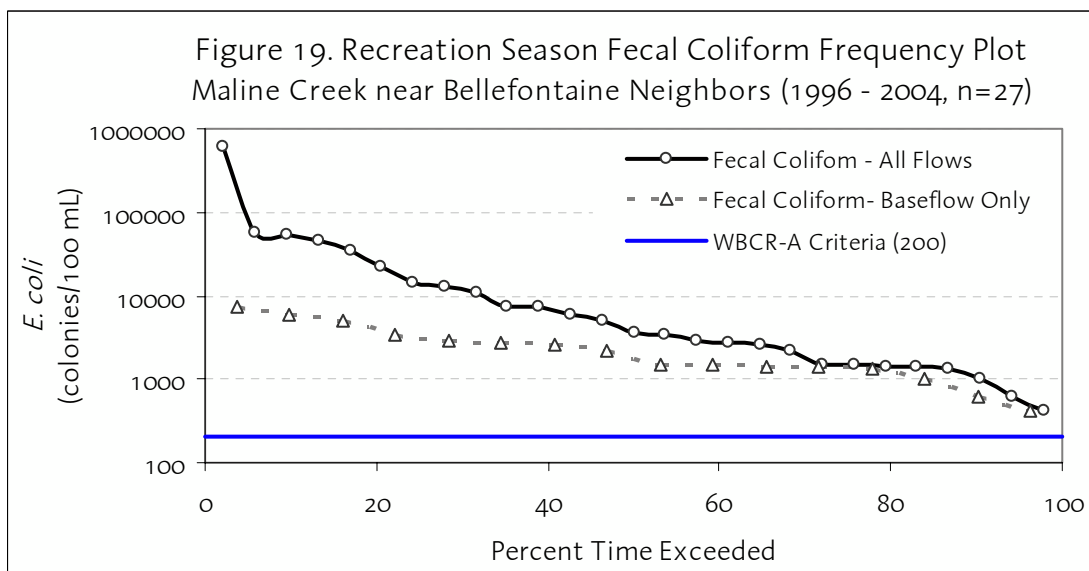
A frequency plot of recreation season bacteria data collected by the U.S. Geologic Survey in Maline Creek from 1996 through 2004 (Appendix C) indicate that the proposed *E. coli* WBCR-A criterion was not met during the eight year period of record, even during baseflow conditions (Figure 18). In addition, the proposed *E. coli* WBCR-B criterion was exceeded within 86% of collected samples (Figure 18). Recreation season geometric means listed by year and flow condition indicate that neither the proposed WBCR-A or WBCR-B *E. coli* criteria were met (Table 7). The existing fecal coliform WBCR-A criterion has not been met near Bellafontaine Neighbors during the eight year period (Figure 19, Table 8). Therefore, available data indicate that Maline Creek water quality does not meet levels required to support WBCR uses during the recreation season.

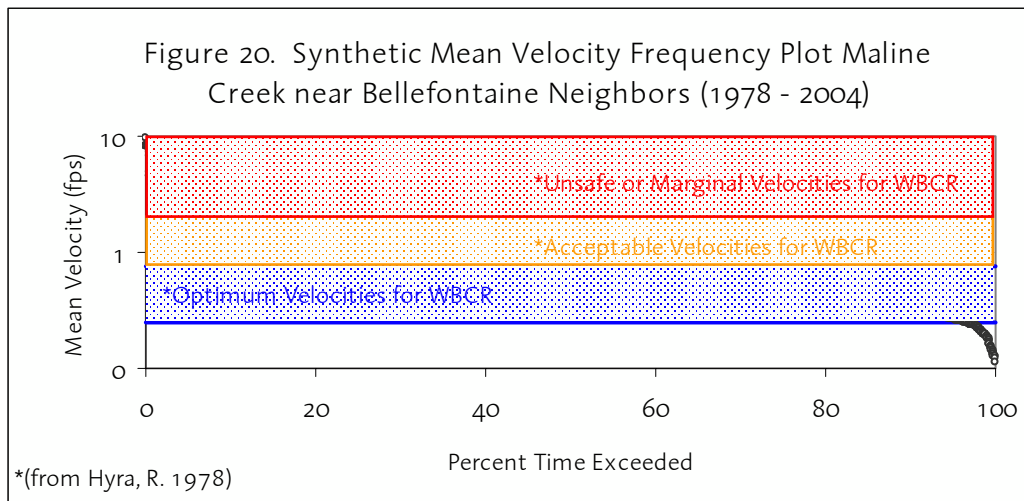
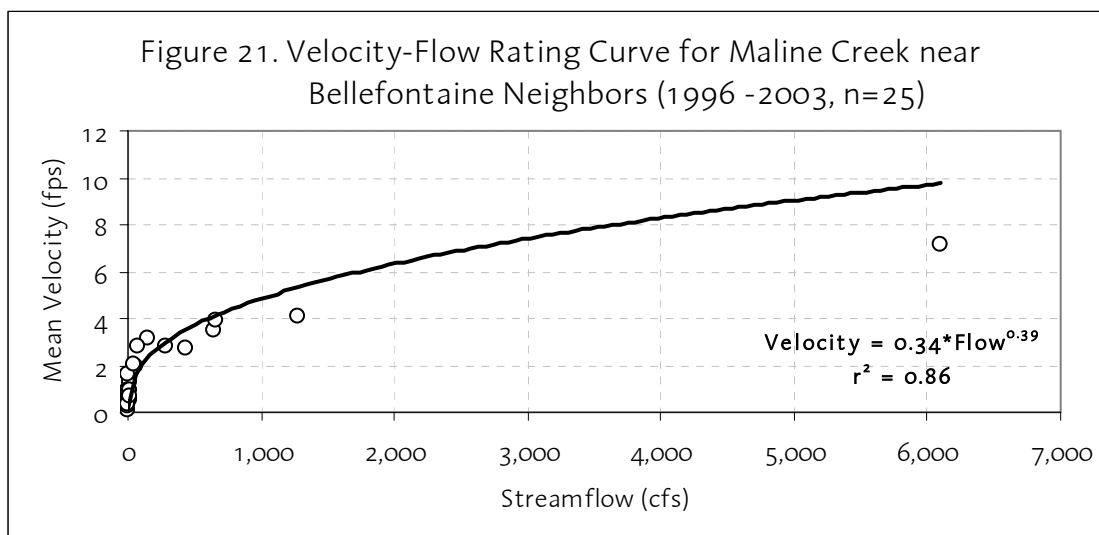
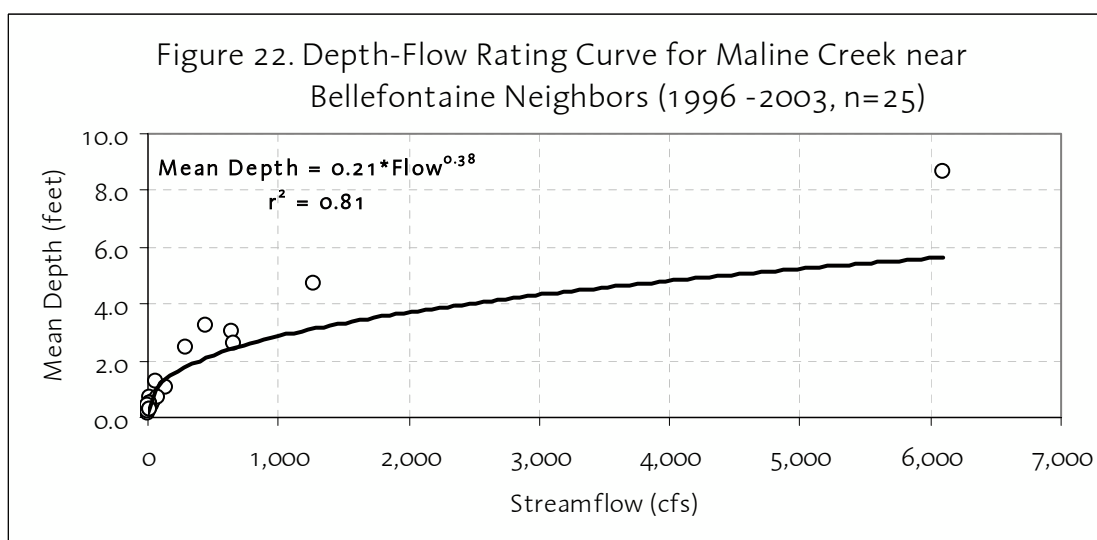
Water depths supporting WBCR at the Bellefontaine gage are apparently reached at flows that induce marginal or unsafe swimming velocities due to hydrologic modifications. Mean depth thresholds ( $\geq 1.64$  feet) set forth in MDNR UAA protocols correspond to flows near 230 cfs according to the depth-flow rating curve developed for the Bellefontaine gage (Figure 21). However, the extent to which channel characteristics at the Bellefontaine gage are applicable to ungaged sites within the study reach is uncertain. Mean depth of surveyed reaches (0.9 ft) measured during October surveys at 0.4 cfs is larger than mean depths predicted at 0.4 cfs by the Bellefontaine depth-flow rating curve (0.15 ft.).

This analysis demonstrates that WBCR uses may be unattainable due to hydrologic modifications that result in high velocities during some periods of stormwater runoff.
